Manhole Inspection Summary

Manhole # S43EE_036MH

Inspection ☐ Is Incomplete Rating: **4) Poor**

Location Address: **1634 CHASE ST**

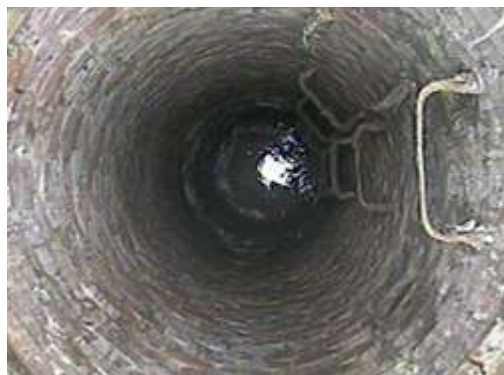
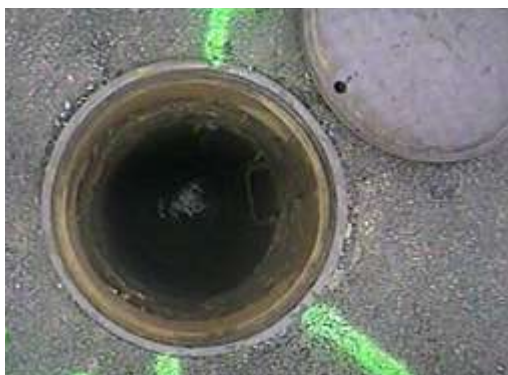
Top View

Comments **100IN PIPES @12/4, DOF-78IN, SILT-31IN, RTC - @12-17.71 @4-17.68 Pipe too big - topv view cannot show the channel**

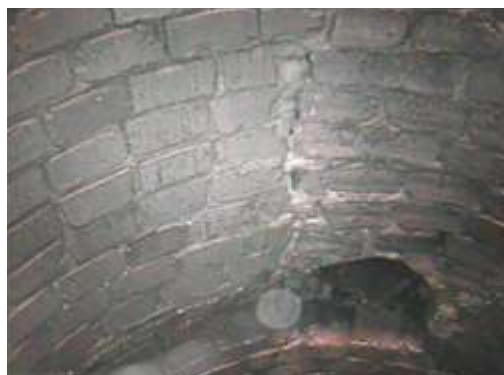
Defect 2

Condition: ☐ Sound ☒ **Cracked** ☐ Root Intrusion ☒ **Loose Brick** ☐ Deteriorated

CRACKED CHIMNEY, LOOSE BRICKS

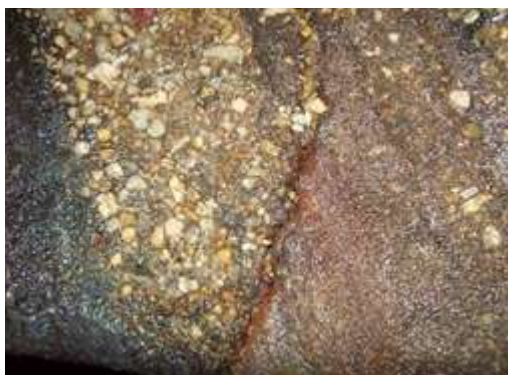
Defect 1

Condition: ☐ Sound ☒ **Cracked** ☐ Root Intrusion ☐ Loose Brick ☐ Deteriorated

CRACKED BARREL

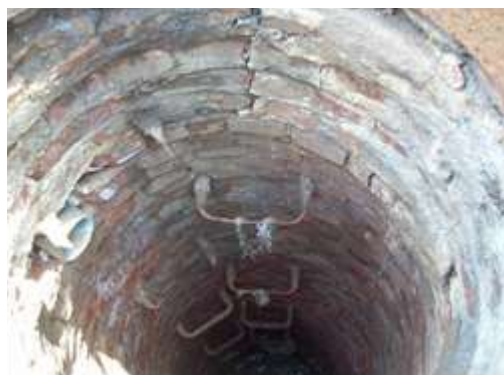
Defect 3

Count: **12** Missing: **2** ☒ **Corroded**

☒ **Evidence Of Surcharge** Depth: **11** (ft.) ☐ Active Surcharge Present

Evidence of surcharge, corroded steps

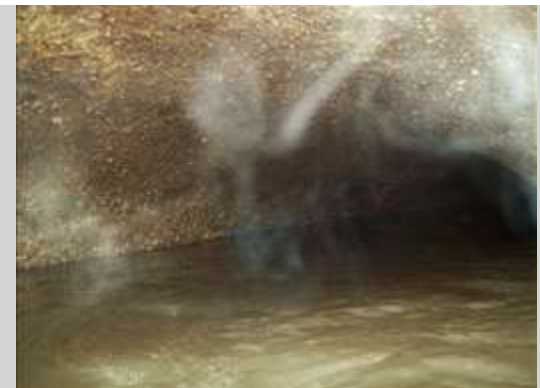
12 O'Clock Outflow

72 in. Circular Gravity Sewer
Pipe Out @ 12 O'Clock

Deposits: ☐ None ☐ Mud ☐ Sludge ☒ **Debris** ☐ Grease

Silt Depth: **31** (in.) Deposits Extent: **Medium**

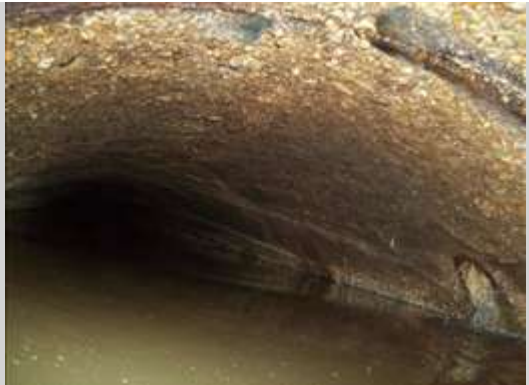
4 O'Clock Inflow

72 in. Circular Gravity Sewer
Pipe In @ 4 O'Clock

Pipe Height: (in.) Direct
Pipe Material: **Concrete** ☐ Pipe Lined
Invert Depth: **17.68** (ft.) Flow Characteristics: **Slow**
Deposits: ☐ None ☐ Mud ☐ Sludge ☒ **Debris** ☐ Grease
Silt Depth: **31** (in.) Deposits Extent: **Medium**
Infiltration: **None** Pipe Seal Cond: **Sound**

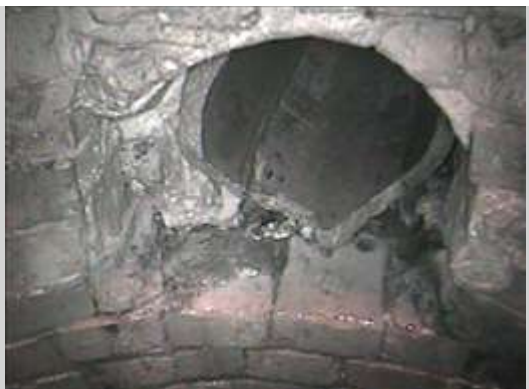
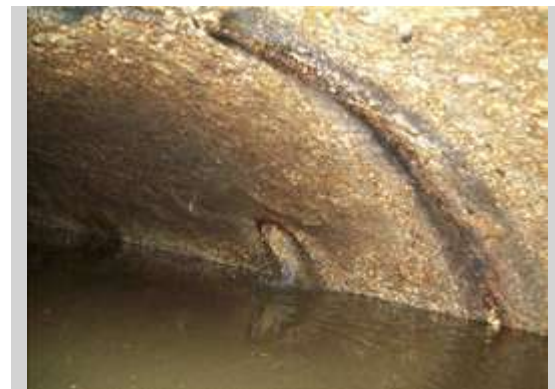
6 O'Clock Inflow

8 in. Circular Gravity Sewer
Pipe In @ 6 O'Clock

Pipe Height: (in.) Direct
Pipe Material: **Clay** ☐ Pipe Lined
Invert Depth: **12.66** (ft.) Flow Characteristics: **Slow**
Deposits: ☐ None ☐ Mud ☐ Sludge ☒ **Debris** ☐ Grease
Silt Depth: **2** (in.) Deposits Extent: **Medium**
Infiltration: **Gusher** Pipe Seal Cond: **Broken**

Drop: **Outside Direct**
Angled: Reading: (ft.)
Inv Depth: **19.19** (ft.)
Drop Condition: **Open**
